DETERIORATION OF TWISTED NITI FILES WITH CLINICAL USE—A DENTAL OPERATING MICROSCOPIC STUDY

Manal Mohamed Abdelbaki*

The present study aimed to evaluate the ability of DOM to demonstrate the signs of instrument's distortion and to investigate types and frequency of rotary NiTi twisted files (TF) deterioration modes.

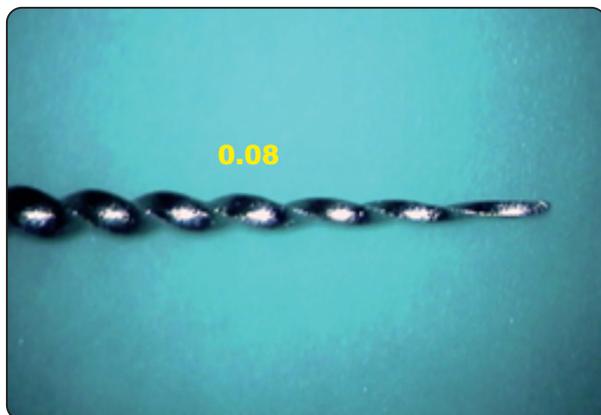
Fig. (1) shows a representative Photo-DOM Photograph of file taper 0.08 with no visible sign of instruments blade deterioration.

The highest number of files showing no visible defect was found in files taper 0.10. This was followed by taper 0.04, 0.08. in a descending order respectively with no significant differences between them figure 1. Taper 0.06, however, showed a significantly lowest number of no visible defect features (table 1).

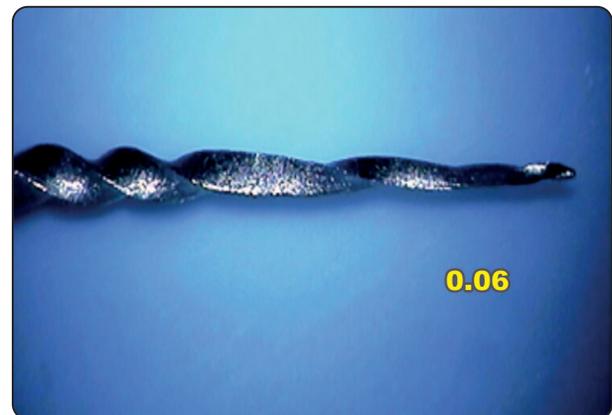
Fig. (2) (left): Photo-DOM micrograph showing unwinding in a TF of taper 0.06. Note that it occurred at the third flute

This feature was found to occur in a percentage that ranged from 40.9% in instruments of 0.08 taper to 22.3% in both instruments tapers 0.04 and 0.010 (figures 2 and 3). 36.4% of TF files taper 0.06 showed unwinding (table 1). No significant differences were found between the groups

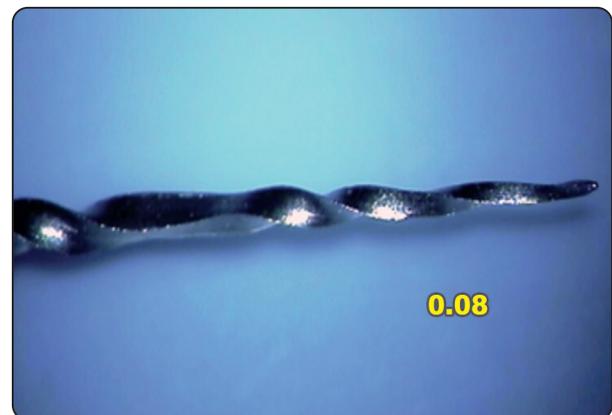
Fig. (3) (right): Photo-DOM micrograph showing unwinding in TF of taper 0.08. Note that it occurred between the third fourth flute

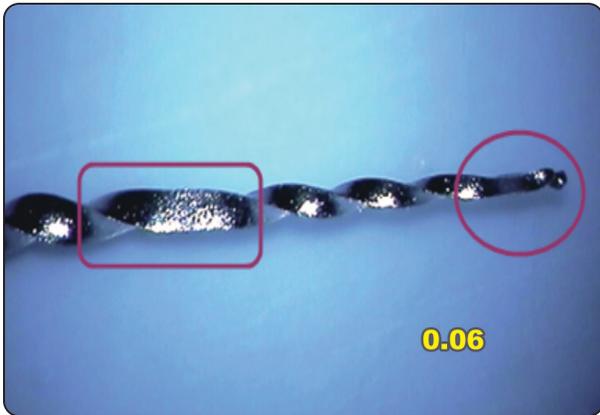
Fig. (4): Photo-DOM micrograph showing: Over-twisting at the tip of TF taper 0.06 at the and unwinding at the 4th flute in the same instrument

This feature was seen in taper 0.06 were 3 instruments out of 22 (13.6 %) showed over-twisting (figure 4). Again, one instrument out of the 22 TF studied of taper 0.04 showed blade over-twisting. A statistically significant difference was found between them and tapers 0.08 and 0.010 (table 1).

0.06 were 3 instruments out of 22 (13.6 %) showed over-twisting (figure 4). Again, one instrument out of the 22 TF studied of taper 0.04 showed blade over-twisting.

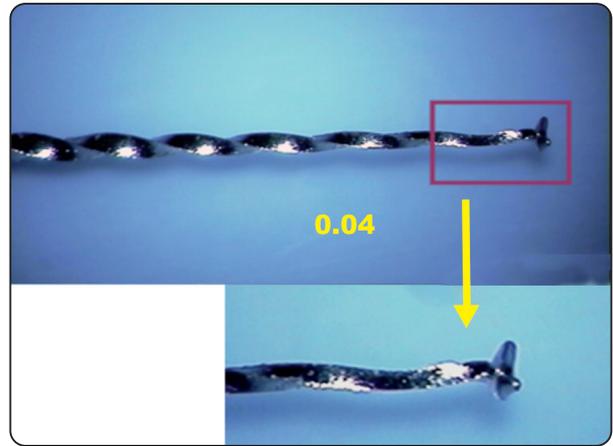
Fig. (5): Photo-DOM micrograph of a taper 0.04 TF- showing blade turn over at the tip and unwinding at the second-third flute (up). A higher magnification of the instrument's deterioration features (magnified)

Occurred mostly in the smaller taper TF instruments of taper 0.04 (22.7 %), (figure 5) and in a lower percent of taper 0.06 (9%) respectively (table 2). This feature however, was not found in larger taper TF files.

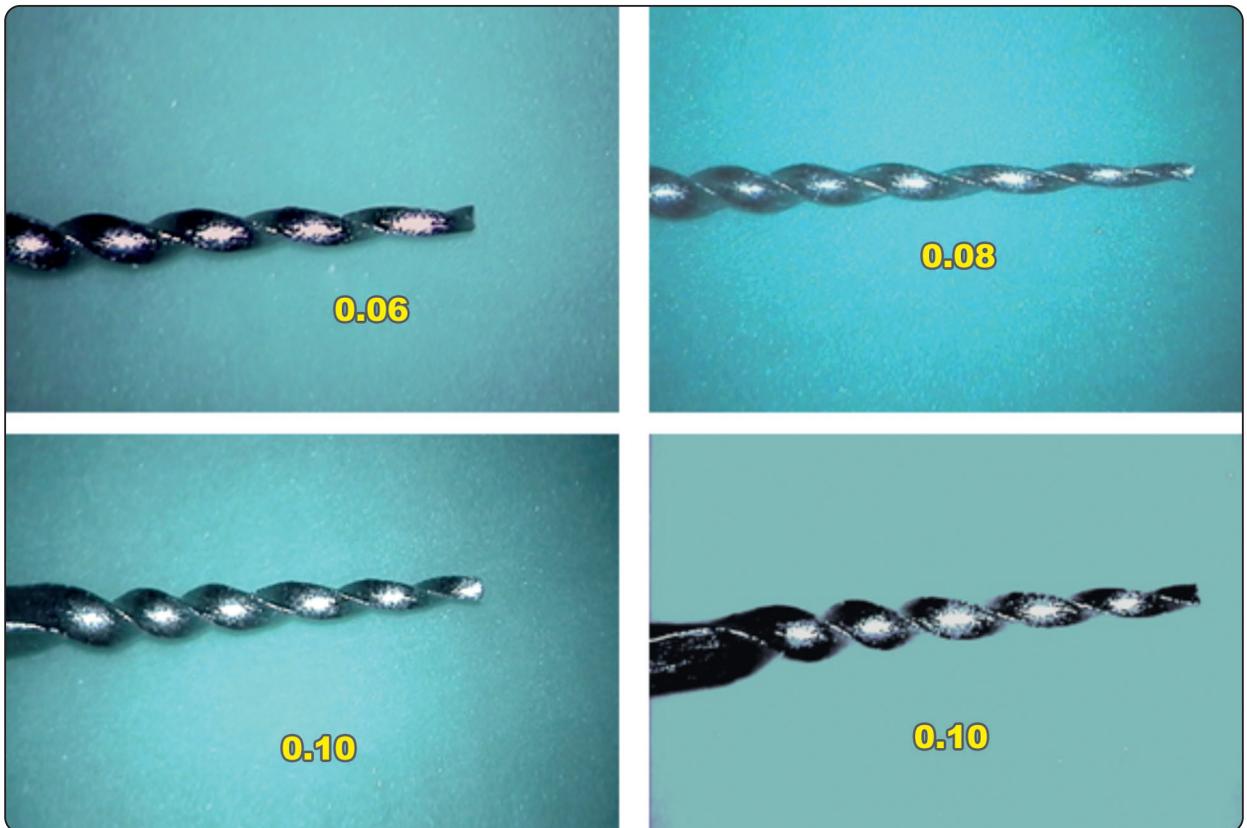
Fig. (6): Composite photo-DOM micrograph showing representative fractured TF at about 3mm. from the instruments tips in all instrument tapers (except the 0.04 taper TF). Note that fracture occurred without further defects \ (flexural type fatigue)

This feature was found mostly in taper 0.08 in

22.7% followed by both file tapers 0.06 and 0.010 in equal percentages of 18.2 each (table 2 and figure 5). No one of the studied taper 0.04 TF files showed tip fracture.
